MARINE ACCIDENT INVESTIGATION BRANCH

## FLYER TO THE LEISURE INDUSTRY

### OUZO:

### ACCIDENT WITH THREE FATALITIES 21 AUGUST 2006

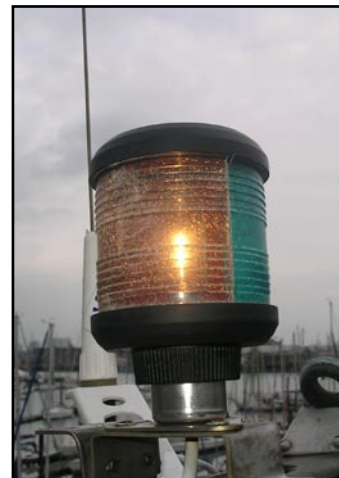
- i. The lenses of navigation light units similar to the one fitted to *Ouzo* are prone to crazing which substantially reduces their efficiency. **(as shown on photo)**

**Yacht owners should make every effort to ensure that their navigation lights are fully effective, and their characteristics understood.**
